# HOME INSPECTION

June 29, 2019

123 Main Street, Philadelphia, PA, USA

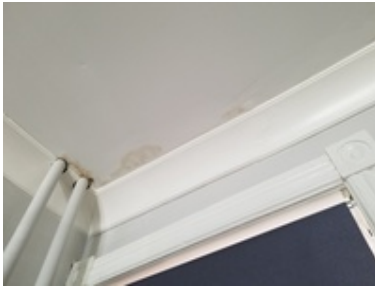
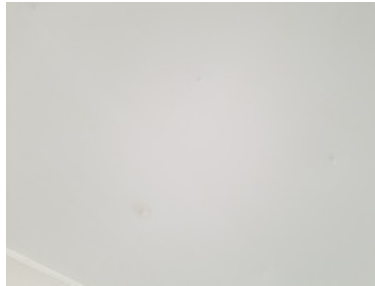
## ● 1) LEAK (BEDROOMS / LIVING AREAS)

There is a leak under the second floor bathroom visible in the family room.  
Recommend making repairs to prevent water damage.

Estimated cost to repair: \$400 - \$800

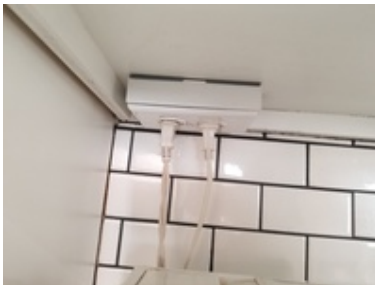
## ● 2) MISSING GFCI (ELECTRICAL)

There is a missing GFCI protected outlet in the kitchen. Recommend making repairs for safety.

Estimated cost to repair: \$50 - \$100

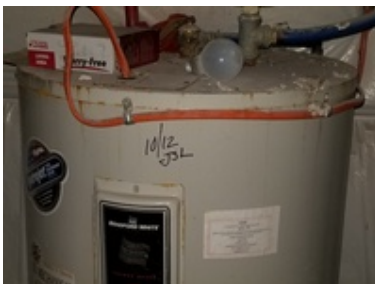
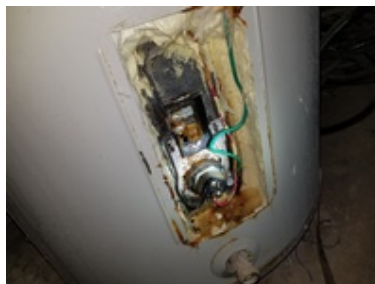
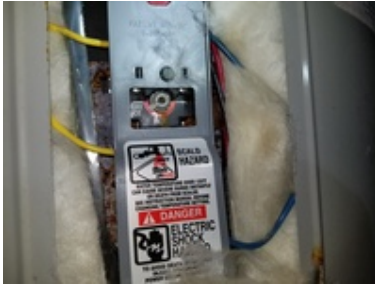
## ● 3) WATER HEATER CORROSION (PLUMBING)

The water heater has corrosion inside the casing; this may be due to leaking. The contacts are rusted; this is a safety hazard. Recommend making repairs or replacing the water heater.

Estimated cost to repair: \$500 - \$1,500

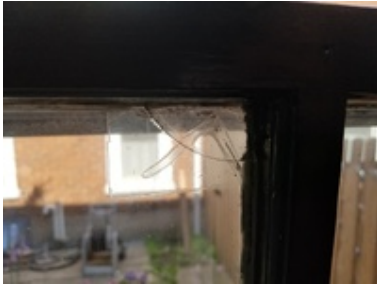
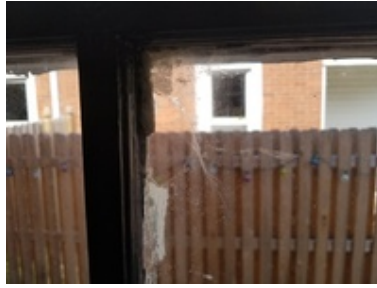
#### ● 5) BROKEN WINDOWS (BEDROOMS / LIVING AREAS)

Some of the windows in the home have broken glass. Recommend repairing the windows for safety.

Estimated cost to repair: \$100 - \$400

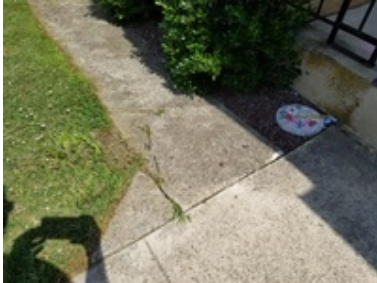
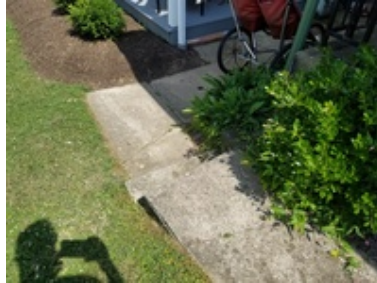
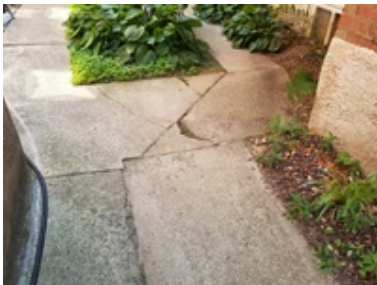
## ● 6) DAMAGED WALKWAYS (EXTERIOR)

There are cracks and minor heaving at the walkway in multiple areas. Recommend repairing the walk to prevent further deterioration and trip hazards.

Estimated cost to repair: \$200 - \$600

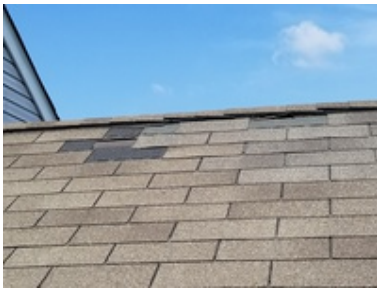
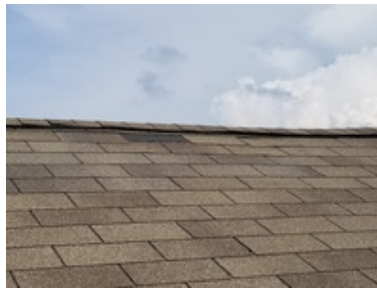
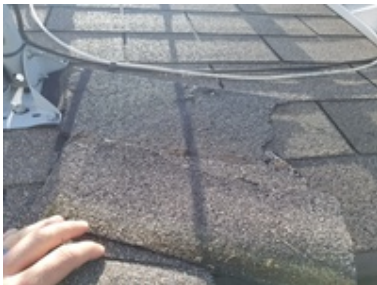
## ● 7) MISSING SHINGLES (ROOFING)

There are missing shingles on the roof; this may allow for water damage. Recommend replacing the shingles to prevent leaks.

Estimated cost to repair: \$200 - \$400

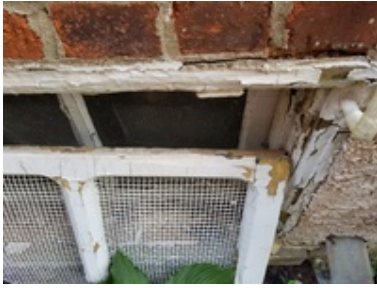
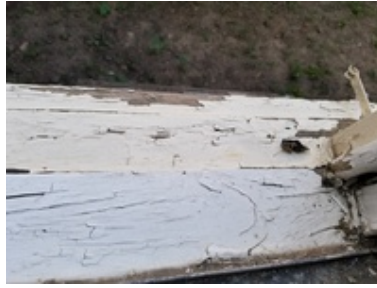
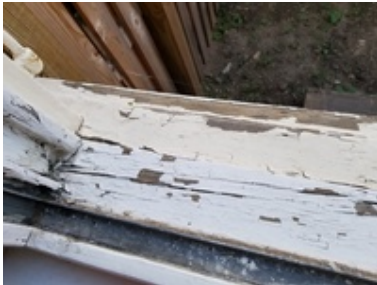
## ● 8) DETERIORATED PAINT (EXTERIOR)

The trim around the windows has deteriorated paint. Recommend repainting the windows to prevent wood rot.

Estimated cost to repair: \$500 - \$1,000

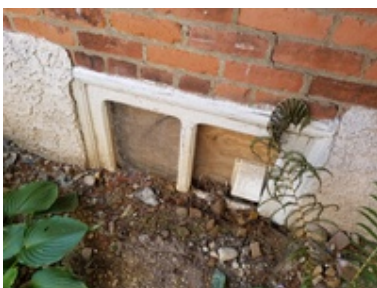
## ● 9) WINDOW WELL (EXTERIOR)

There is a window at ground level; this may allow water to enter into the basement and may cause damage to the trim and framing. Recommend installing a window well for adequate drainage.

Estimated cost to repair: \$300 - \$800

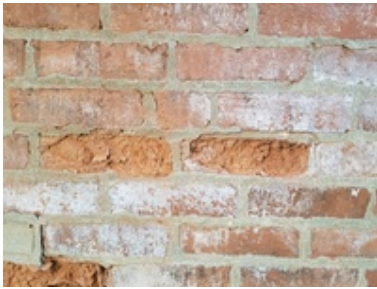
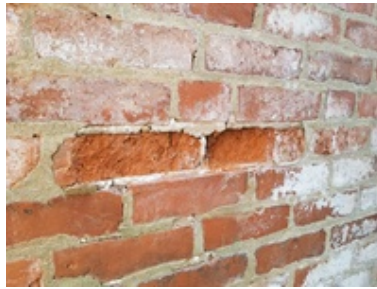
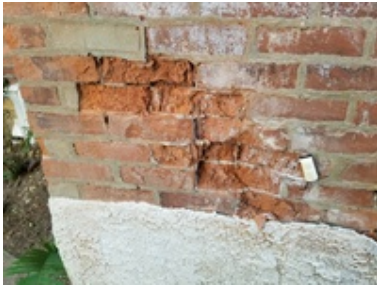
## ● 10) DAMAGED BRICK (EXTERIOR)

There is damaged and spalling brick on the exterior wall. Recommend repairing the brick to prevent further deterioration and damage.

Estimated cost to repair: \$400 - \$800
